RE: January Monthly Report

1.5 Mile Reach Removal Action

GE-Pittsfield/Housatonic River Site

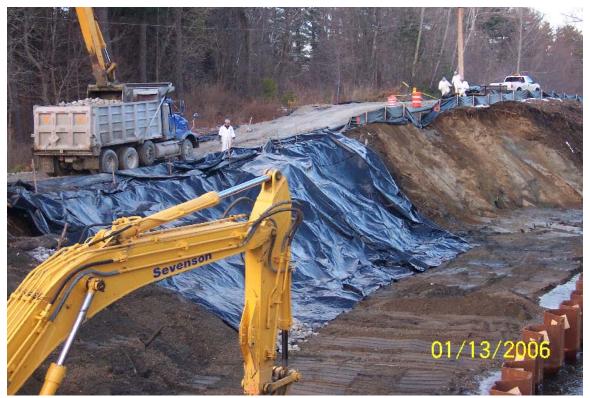
Photograph 1 – Installation of Erosion Prevention Controls in Cell 39

The excavation activities in Cells 39 and 42 were interrupted by heavy rain predictions for the weekend of January 13, 2006. All excavation activities were stopped and erosion prevention measures were exercised to secure the Cells 39 and 42 excavated areas from erosion. Poly was installed on the exposed, excavated riverbanks from the top of the riverbank to the toe of the slope. Nine-inch rip rap was placed on the poly at the toe of the riverbank and sheetpile sections were placed on the poly joint overlaps to anchor everything in place. Additional erosion control riprap was placed at the upstream sheetpile wall of Cell 39 and on the unexcavated riverbanks in Cell 42. In addition, all the sheetpile cutoff walls in Cells 39S, 39 and 42 were driven down approximately three feet and the three cells were flooded. This was done to alleviate the damming effect of the walls and minimize the effects of high flows in upstream areas. The activities associated with the installation of the centerline sheetpile wall were also stopped due to the high river flows and the barge/ramp pad was removed from the river.

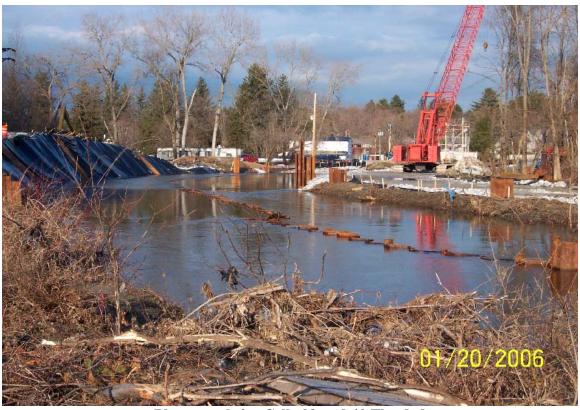
Photograph 2 – Cells 39 and 42 Flooded

Heavy rain combined with snow melt led to high river flows on January 14, 2006. Due to the additional rain and snow melt the river remained under high river flow conditions for a week. During this week, several miscellaneous activities were completed. The decontamination of the WTS HDPE force main pipes was completed. Miscellaneous repairs to the silt fencing and site security fencing were completed. The removal of debris from the trash racks from the temporary river diversion dam was completed. The debris was transported to the Area 64E stockpile management area.

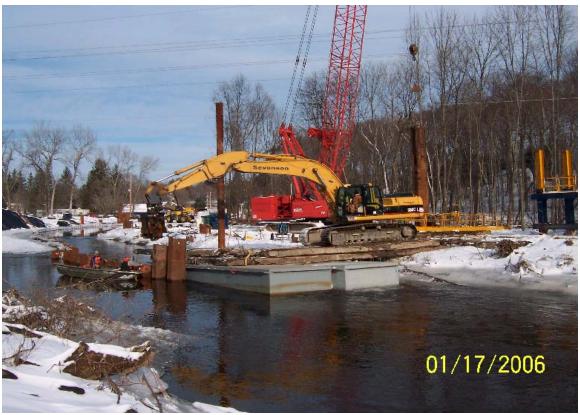
Photograph 3 –Installation of the Centerline Sheetpile Wall under the Power Lines

Also, the installation of the Cell 41/42 centerline sheetpile wall continued. Installation of switches on the Western Massachusetts Electric Company (WMECO) power transmission lines was completed. This allowed a three day shut off of the power lines to ensure safe working conditions during the installation of the centerline sheetpile wall under the power lines. Two barge sections of the temporary floating barge river crossing and a crane mat access ramp were used to build a pad to support an excavator with a movax attachment to install the centerline sheetpile wall beneath the power lines.

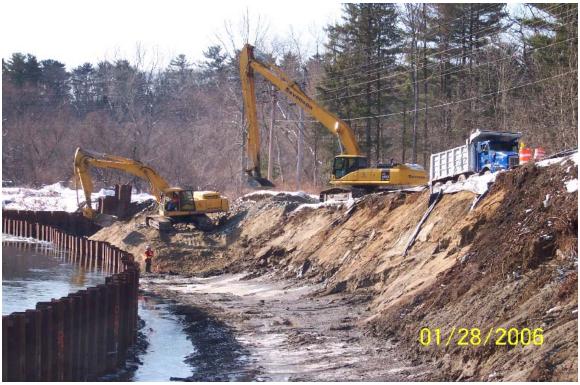
Photograph 4 – Cell 39/42 Excavated; Backfill Ramp Construction

Next, a ramp was build along the riverbank in Cells 39 and 42 to allow access to the cells for backfilling. The ramp was built by using common fill.

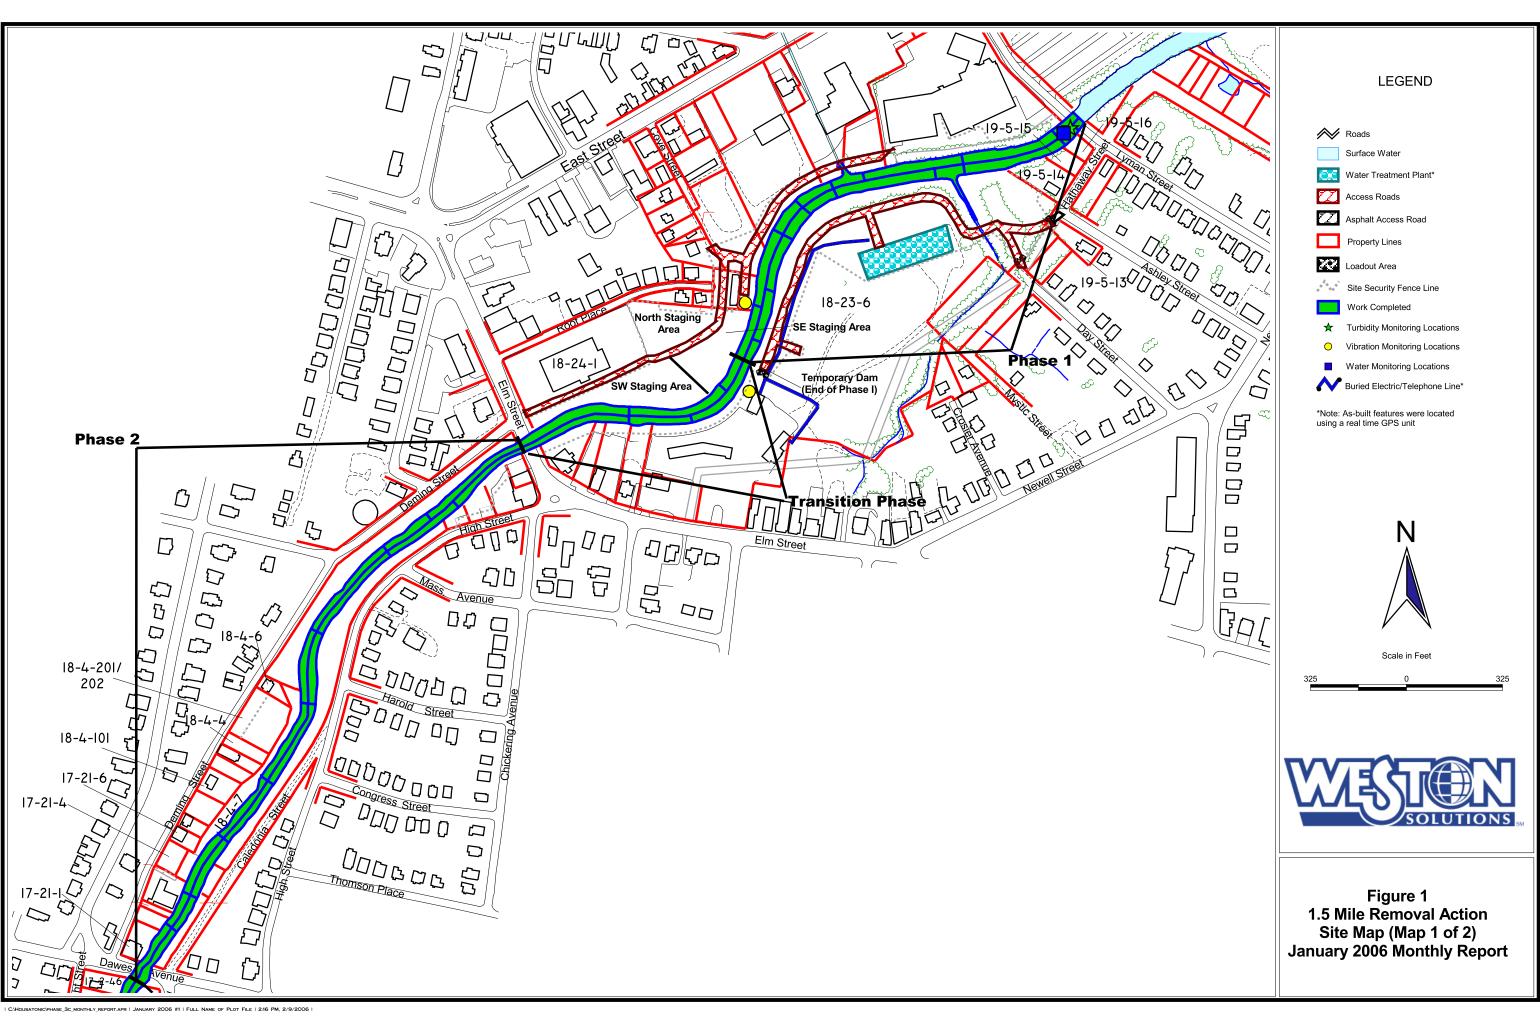
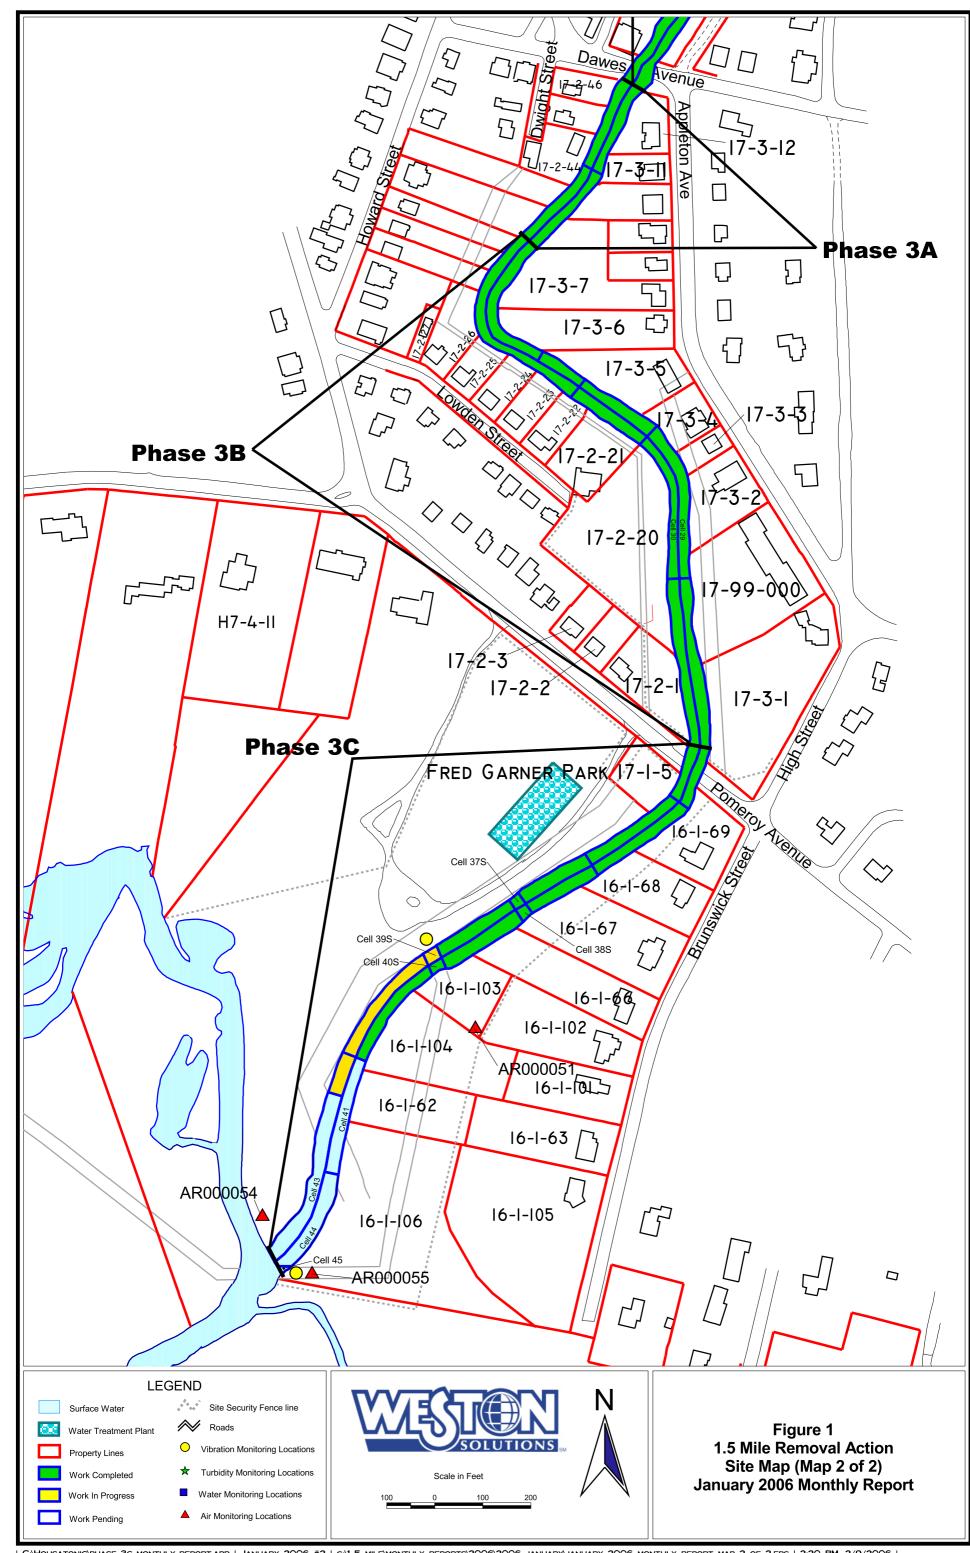
- Figure 1- 1.5 Mile Removal Action Site Map (2 maps)

Figure 1 (2 maps) includes the layout of all excavation cells, the temporary dam, water monitoring locations, air sampling locations, vibration monitoring locations, access road locations, excavation load-out locations, staging area locations, fence line location, and the new and the old water treatment system pad locations.

Refer to Figure 1 (2 maps) for an orientation of the excavation cells and their respective locations.
